## Rate comparison of dent occurrence in back chuck 5

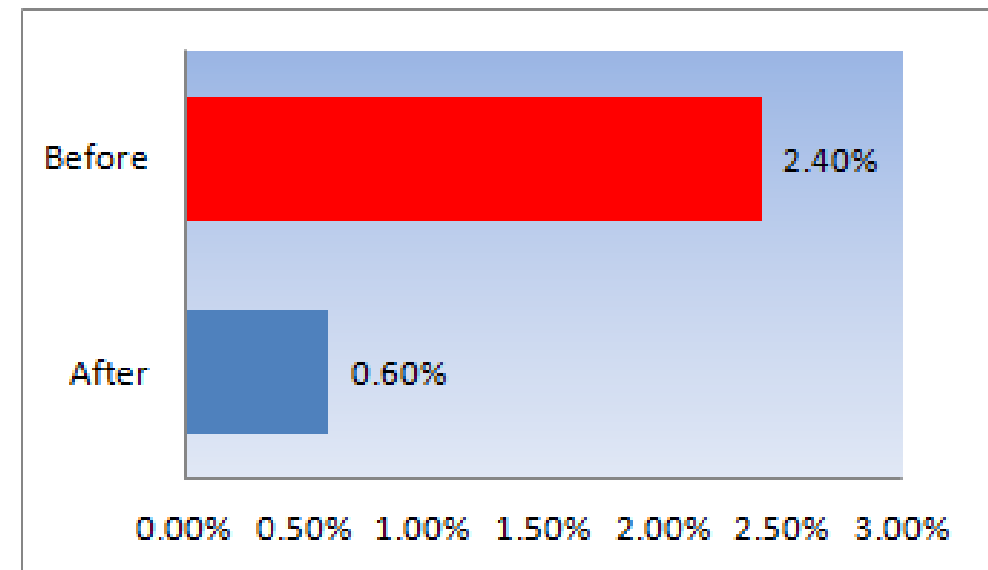
【 Occurrence rate before/after Wavy Nozzle installation】

→ 75% reduce of dent occurrence

- ✓ Machine: NC lathe (C : L16)
- ✓ Coolant: Oil (JIS N3-8)
- ✓ Material: SUS303
- ✓ W/N Mode : Sweep
- ✓ Processing: OD
- ✓ Product Size
  - Length: 29mm
  - Diameter :  $\phi 6.3$
